Report to the PAF WG on the status of the magnets in the existing accelerators

W. Kalbreier, S. Ramberger, D. Smekens, T. Zickler, K. H. Mess

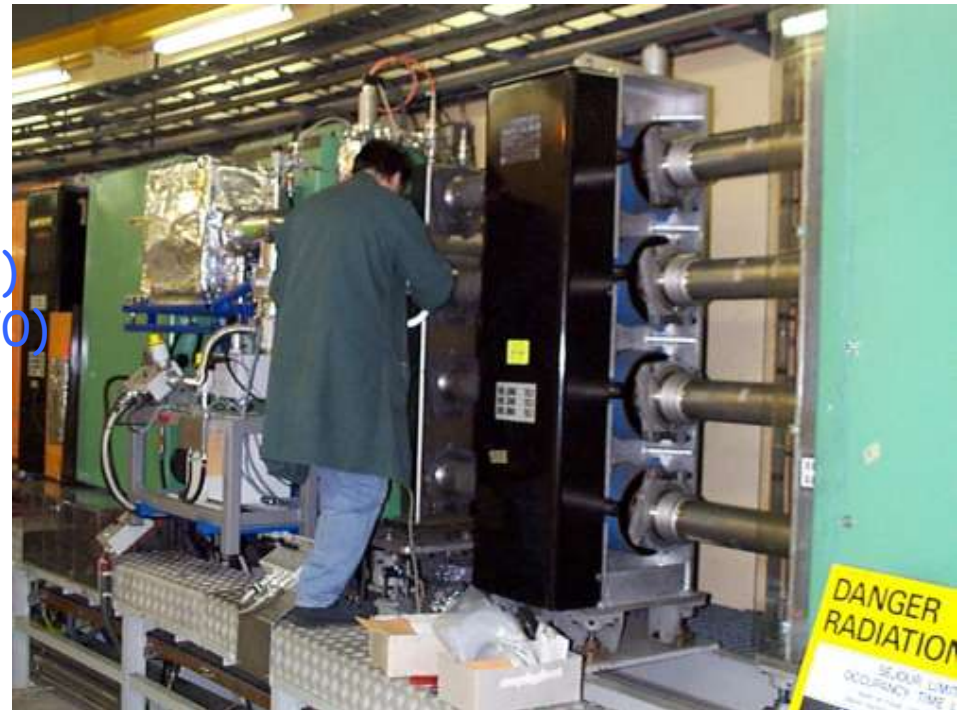
- The main problem encountered was the ageing of the rubber water hoses and seals causing water leaks.
- Water leaks:
 - Many stops in 1998 & 1999 to repair leaks on seals of flexible hoses.
 - All hoses and seals have been replaced in the 4 following shutdowns.
 - No leaks thereafter except in 2004 after the installation of 21 non-conform hoses (replaced during start-up).
 - 1 water collector leaking due to Cu erosion on QDE42 in 2003.
 - 1 water collector leaking on BHZ162 in 2005.
- We plan for an inspection in the next shutdown 2005-06 and replace hoses where necessary.
- There is a reasonable number of spare magnets and coils.

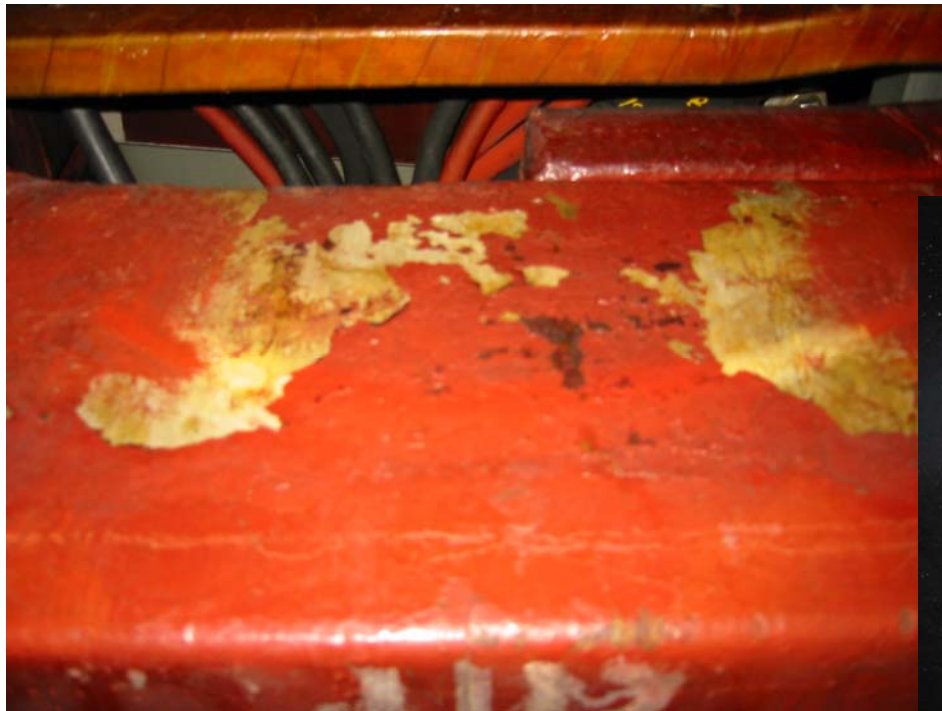
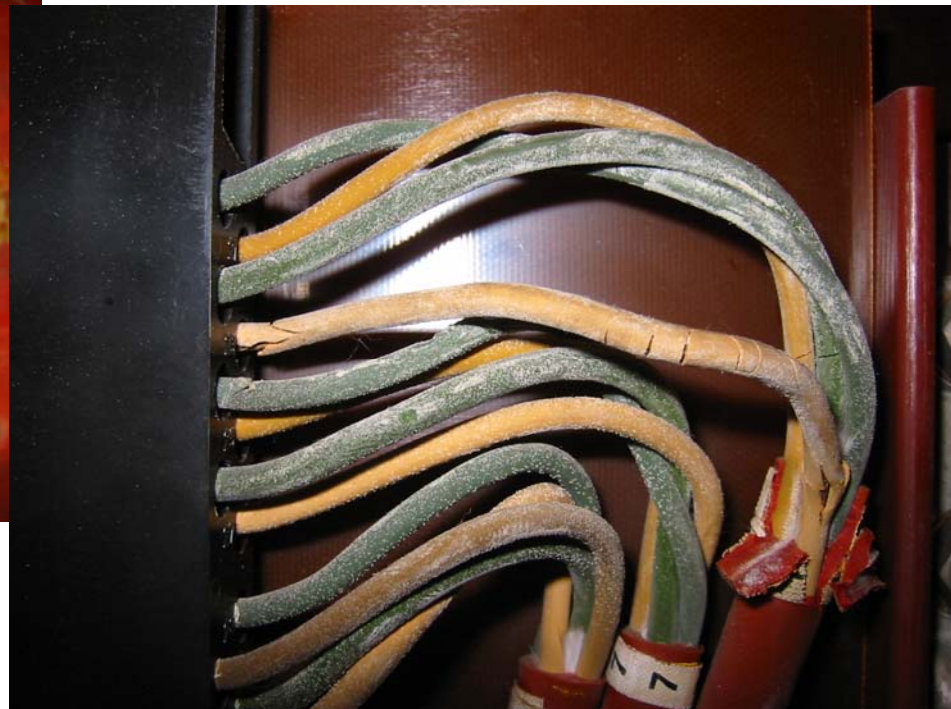
During the routine HV test before the 2003 start-up the coil insulation in 2 PS main magnets was destroyed by breakdown.

An overall inspection of the 45 years old PS main magnets showed heavy degradation induced by radiation and in particular:

- On many magnets the coil insulation was deteriorated and over larger areas no more adhering to the Al-conductor
- Insufficient spare coils with good insulation existed
- The cable insulation of the pole face winding was falling apart when touched

Therefore, in summer 2003 it was decided to launch the PS Magnet Consolidation Project split into two phases :

- Phase I for 2003-2006: Refurbishment of the weakest 40 PS Main Magnets
- Phase II in 2006-2013: Refurbishment of the remaining 60 PS Main Magnets (still to be funded).

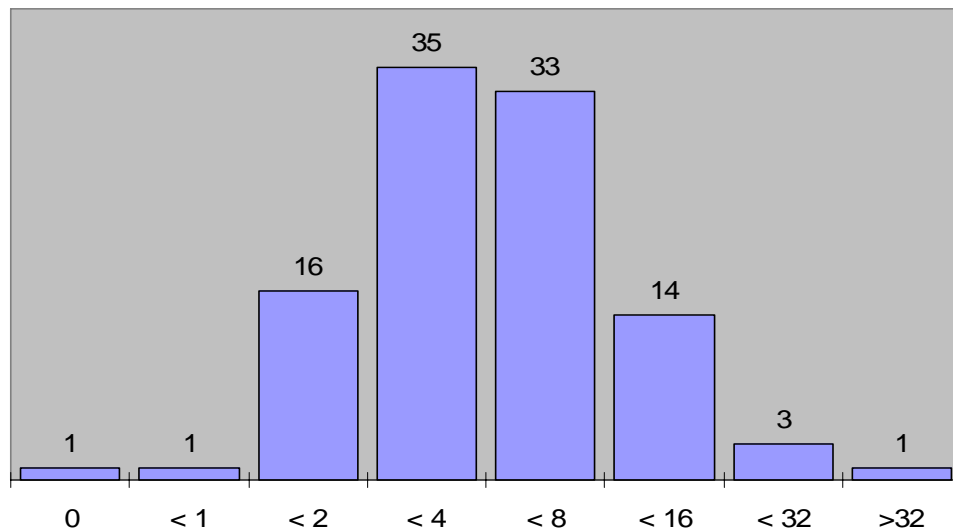
Integrated doses on PS main magnets 1959 - 2004 [MGy]

- The total integrated dose received between 1959 and 2004.
- The actual radioactivity.
- State of the electrical insulation of the main coils.
- State of the PFW cable insulation.
- Voltage seen by the main coils during operation.
- Foreseen PD testing had to be skipped since it was found to be too time consuming.

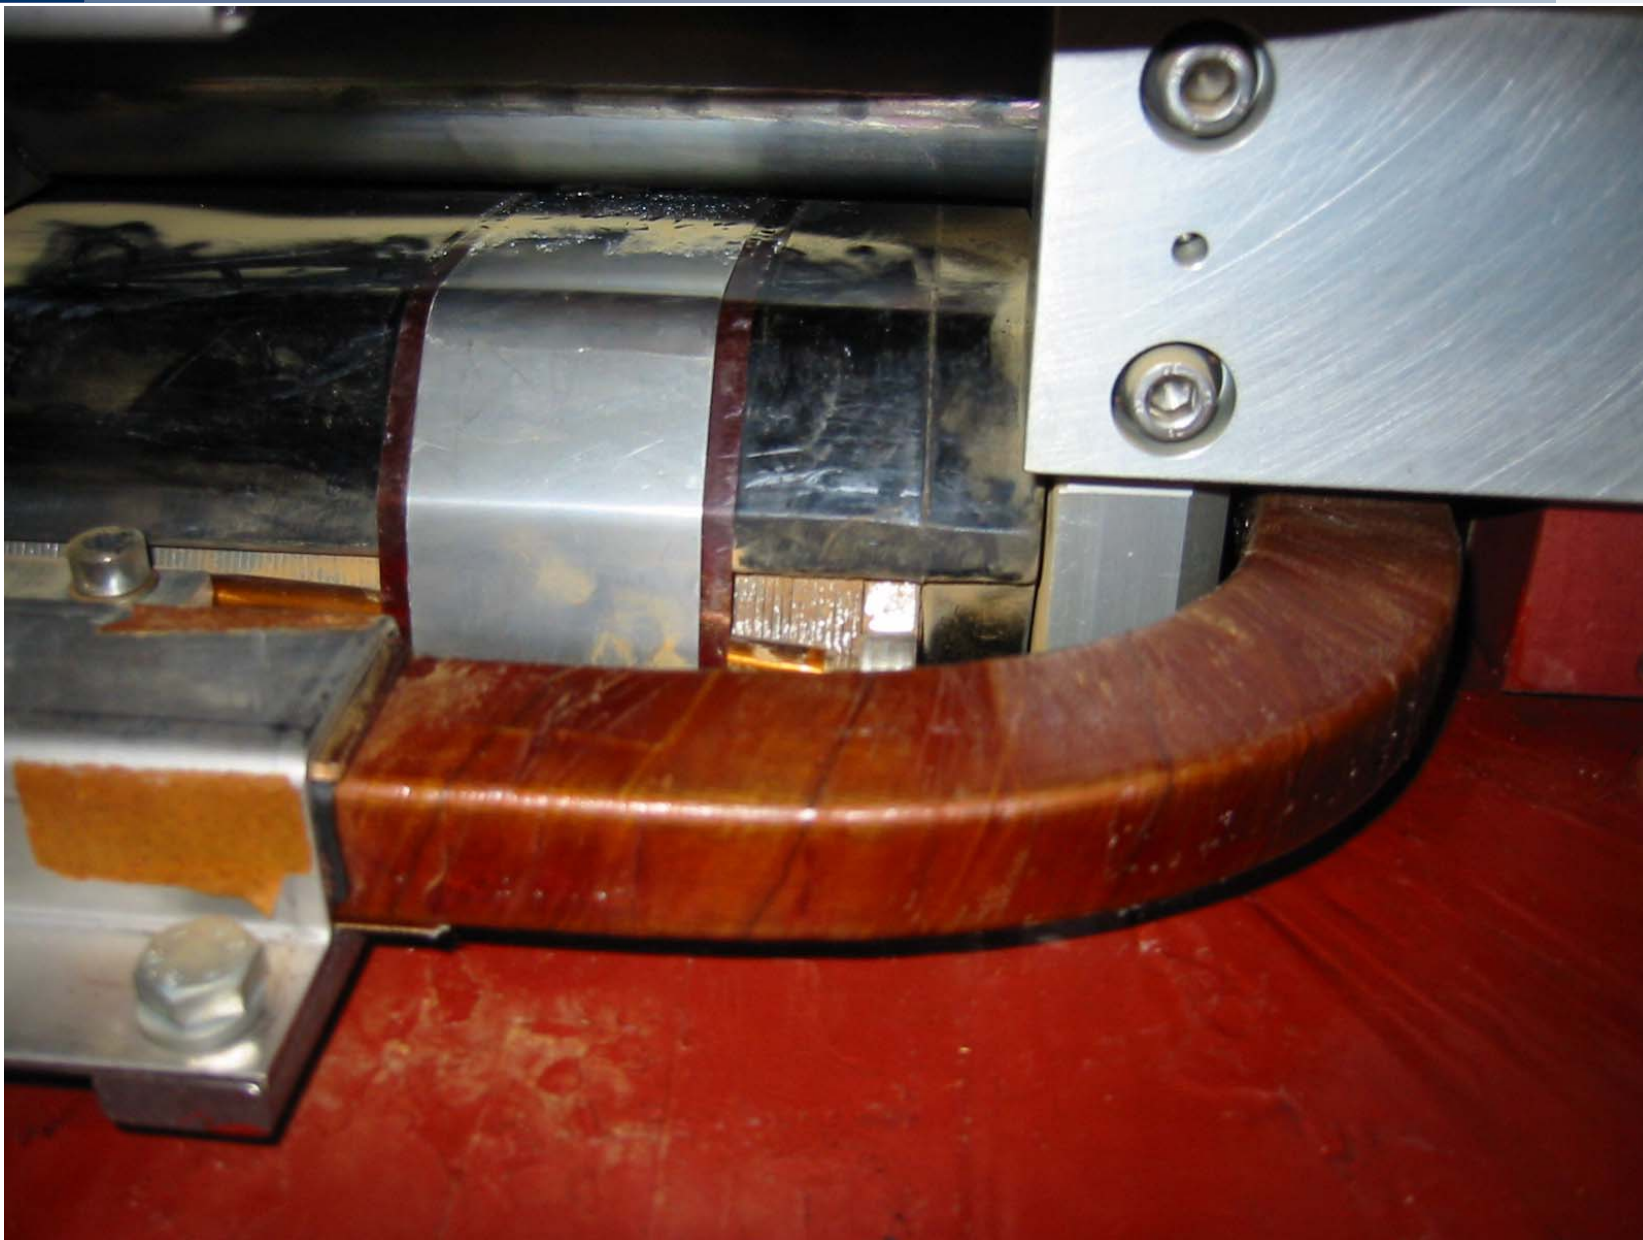
- Already in 1978 a heavy degrading of glue due to radiation was found that should keep together the 1.5 mm thick steel laminations of the 10 blocks forming the yoke.
- The remedy applied was :
 - Exterior blocks #1 + #10: use of tie rods pressing the laminations.
 - Gaps between all other blocks except #5 to #6: insertion of shims to compress the steel laminations.
 - Gap between #5 to #6: insertion of shims to compress the steel laminations impossible because of the passage of the conductor for the figure of eight coil.

- When we disassembled the first PS main magnets in May 2005, we discovered that the degradation of the glue had further advanced. As a consequence loose lamination under the effect of the pulsed field did open up in the gap between blocks #5 & #6 where they cannot be constrained by shims.
- Without repair this effect would have damaged the insulation of the figure of eight coil and led to a short circuit.
- To solve this problem we apply a new gluing in situ of the loose lamination sheets facing this gap and bolt them in addition with a 40 mm long M8 screw.
- A test with 30 kcycles at full field has shown that this method is successful.

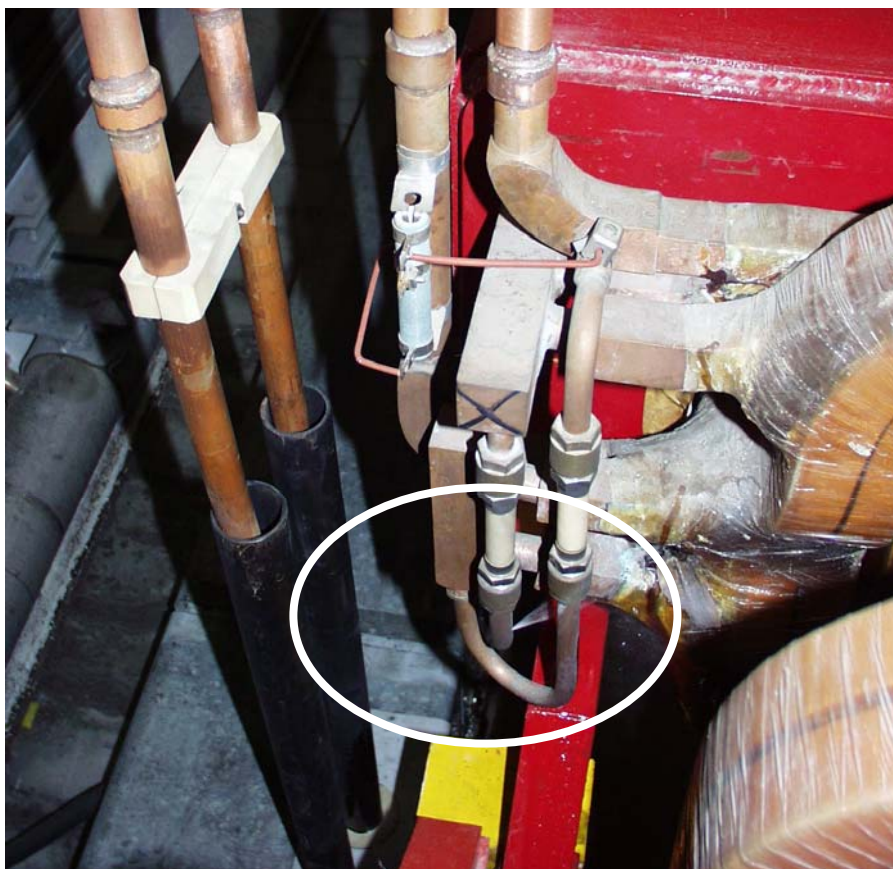
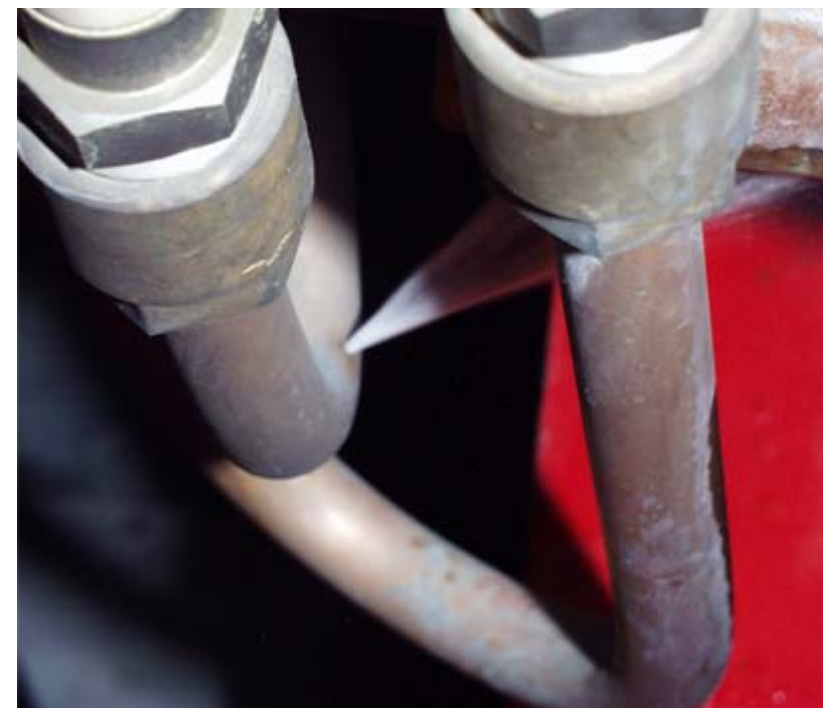
- ➔ Water leak on MBB No. 025 in position 5127 of the SPS. The leak is located on a U shaped standard copper tube and is probably due to erosion. This kind of leak is not repairable (copper tube probably completely eroded and impossible to replace with damaging the coil insulation when brazing a new one)

- In total 7 water leaks the copper tube manifold of the main dipoles MBB have shown up for the 1st time in 2004.
- A repair in situ is impossible because of the insufficient access.
- This could become a series problem for the SPS as it concerns 744 dipoles.
- We could NOT find diagnostics tools to evaluate the amplitude of this erosion problem. Cutting tubes longitudinally revealed that there are many tiny craters especially in the bend parts. → Will be impossible to diagnose this from the outside !
- A removal of about 1 magnet from the ring, the repair in the lab, followed by transport and reinstallation takes about 2.5 days or for 774 magnets about eight years, if carried out sequentially.
