Report to the PAF WG on the status of the magnets in the existing accelerators

W. Kalbreier, S. Ramberger, D. Smekens, T. Zickler, K. H. Mess

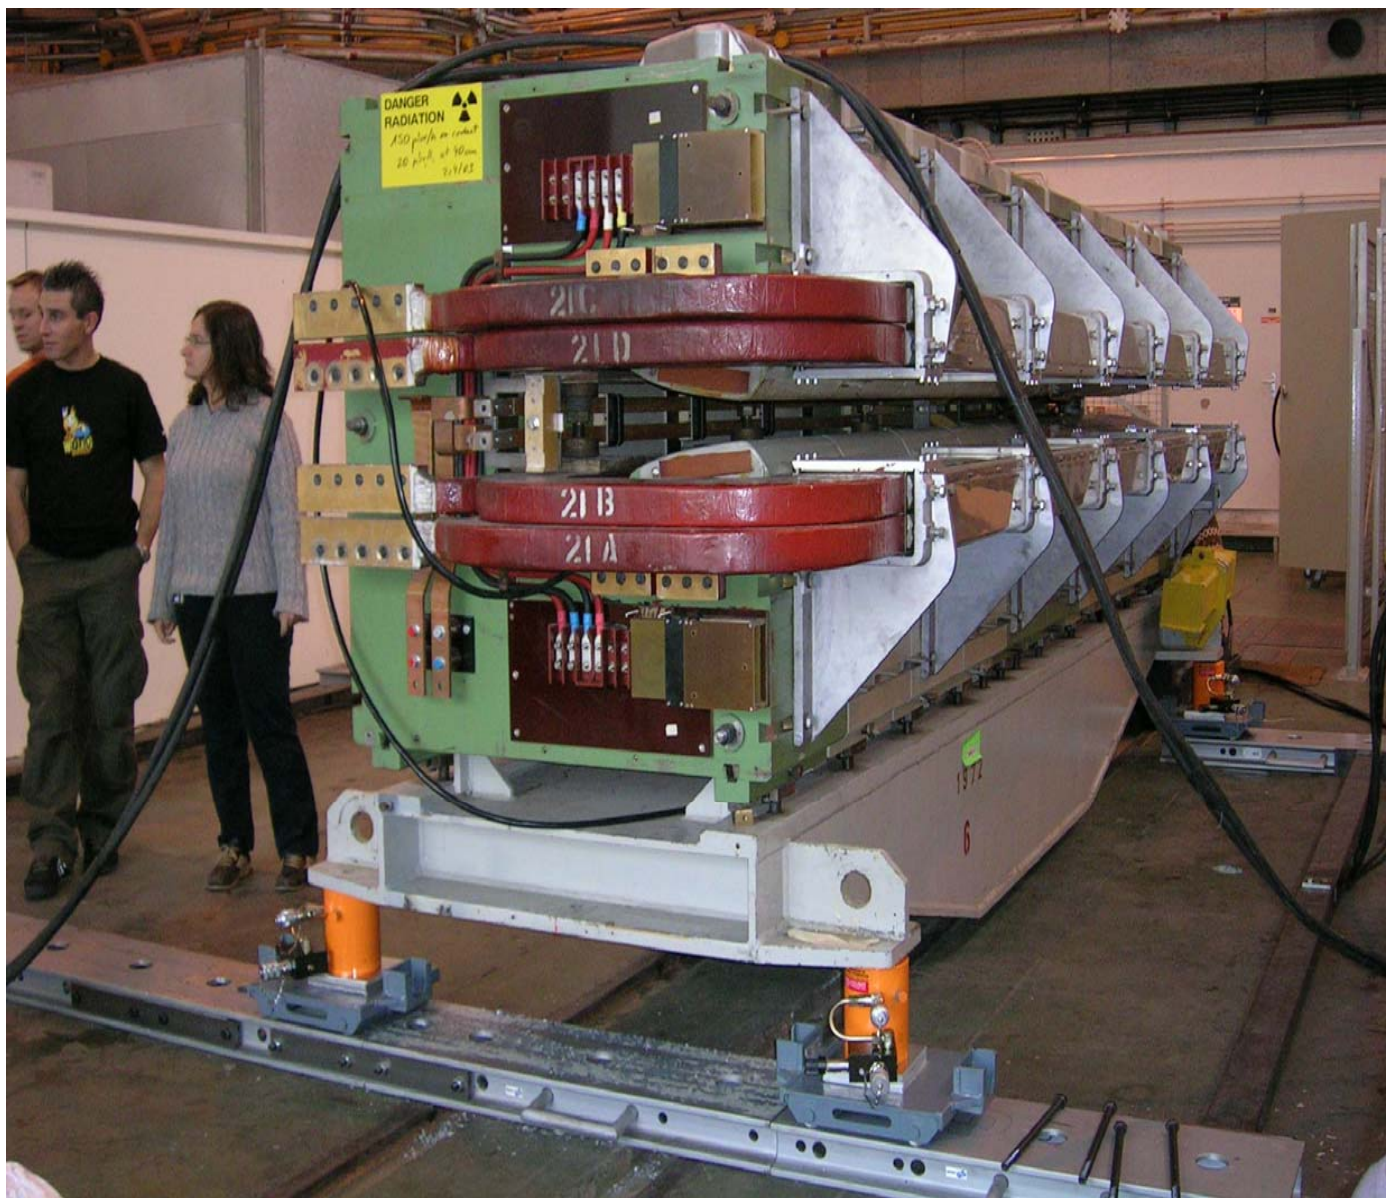
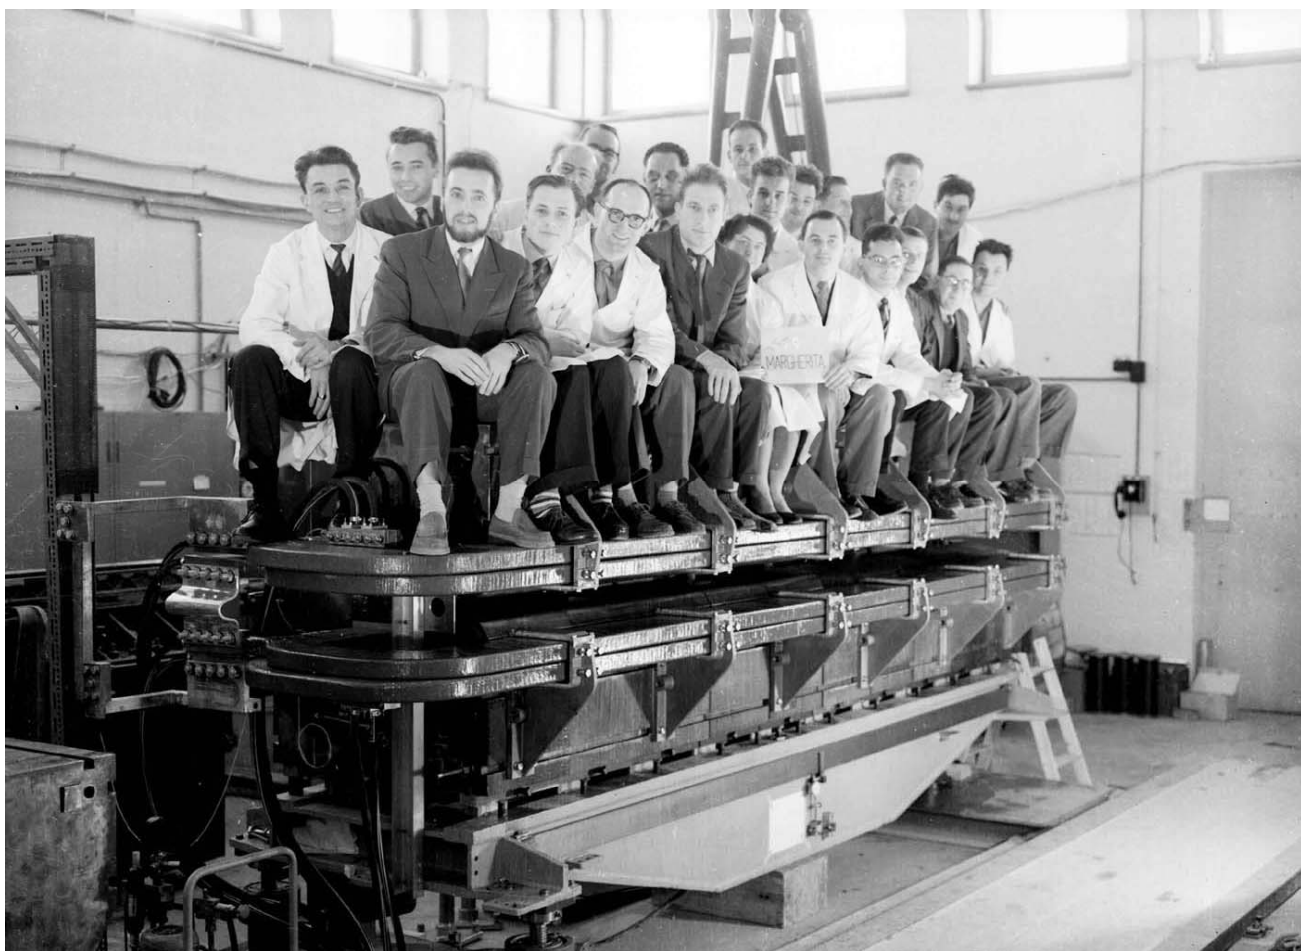
A Main Unit today (PFW and fig. 8 coils removed)

- See the difference in manpower
- and the absence of the figure of eight coils and the PFW

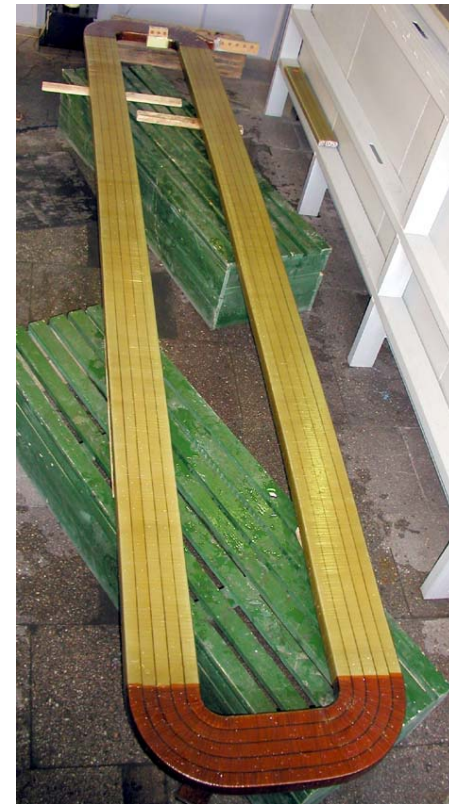
- 232 new main coils (pancakes) are in production at BINP/Novosibirsk.
- Coil prototype has arrived at CERN in December 2004 and was tested successfully.
- Series coil delivery has been delayed by over 4 months and started only in June 2005.
- As a consequence we can only refurbish 24 main magnets instead of the 40 planned.

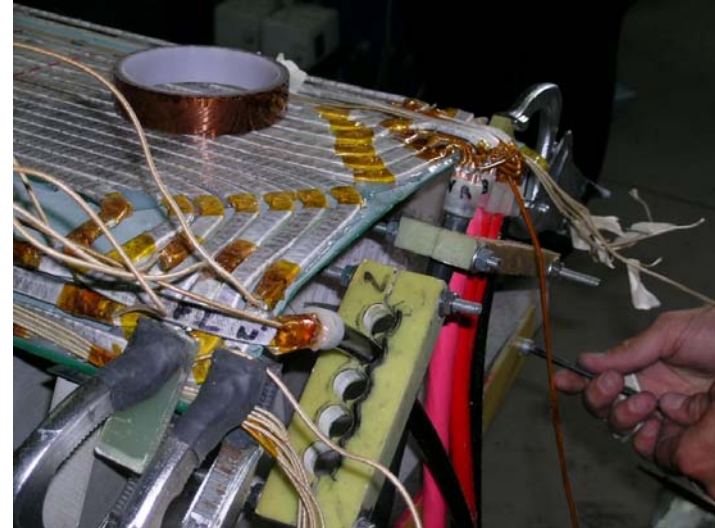
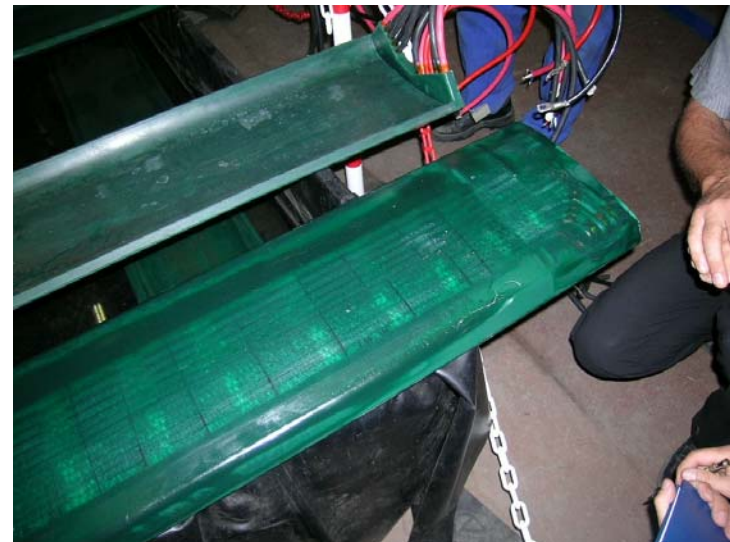
- 240 new Pole Face Windings are in production at SIGMAPHI/ France.
- PFW prototype has arrived at CERN in December 2004 (not conform to specification).
- Series PFW delivery delayed by 4 months to end of May 2005.
- The delays are due to the complexity of the PFW and that SIGMAPHI has underestimated the workload.
- By July the nominal rate of 8 per week was achieved.

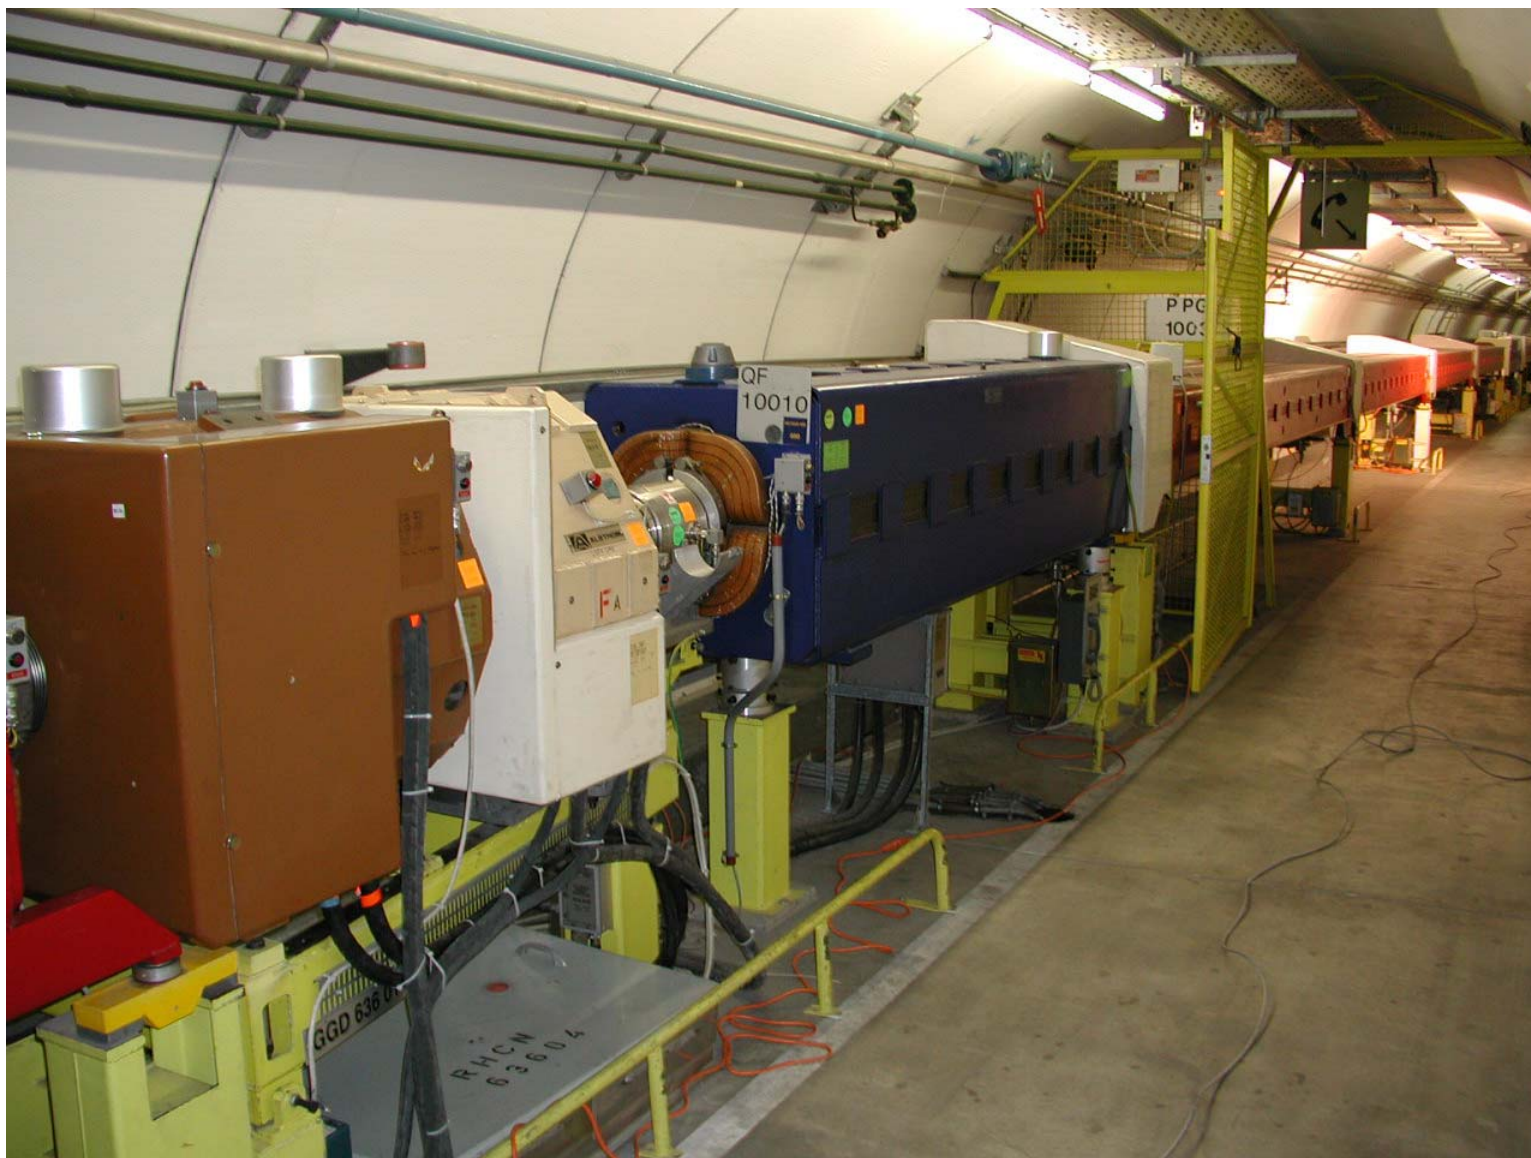
- vacuum leaks due to corrosion in TDC2 splitter area killed a collimator device, the collimator was exchanged. The splitters are attacked by acid, but are still air tight;
- several water leaks (not repairable) on MBA/MBB dipole manifold, presumably because erosion.

- ➔ Water leak on MBB No. 025 in position 5127 of the SPS. The leak is located on a U shaped standard copper tube and is probably due to erosion. This kind of leak is not repairable (copper tube probably completely eroded and impossible to replace with damaging the coil insulation when brazing a new one)

- In total 7 water leaks the copper tube manifold of the main dipoles MBB have shown up for the 1st time in 2004.
- A repair in situ is impossible because of the insufficient access.
- This could become a series problem for the SPS as it concerns 744 dipoles.
- We could NOT find diagnostics tools to evaluate the amplitude of this erosion problem. Cutting tubes longitudinally revealed that there are many tiny craters especially in the bend parts. → Will be impossible to diagnose this from the outside !
- A removal of about 1 magnet from the ring, the repair in the lab, followed by transport and reinstallation takes about 2.5 days or for 774 magnets about eight years, if carried out sequentially.

→ Appendix VIII and the conclusions recommend:

→ A strategic reserve of about 5 Mio CHF, to be kept somewhere at CERN which would cover catastrophic events such as for example:
